# Causes of Landslides in Road Embankment with Retaining Wall and Pile Foundation: A Case Study of National Road Project in Porong-Sidoarjo, Indonesia

**Abstract**— This study was conducted to determine the cause of landslides in the toll road embankment of the national road project in the Porong-Sidoarjo area. The landslide was observed only on the north side of the embankment, with a maximum height of 7.8 meters from the subgrade despite the reinforcement with a retaining wall and pile foundation. The land shift and subsidence on the Northside led to a decline in the embankment elevation and the displacement to a maximum depth of 3.50 m. Back analysis through the limit equilibrium method was used to determine the strength of the existing reinforcement against the landslide. The results showed that the heavy rain was indeed one of the causes of landslides in the location, while the main cause was the depth of soft soil, much deeper than those in the surrounding locations. This is why a severe landslide was recorded on one side of the embankment. Moreover, the existing anti-slide pile reinforcement was discovered not to be sufficient due to its shallower length compared to the are

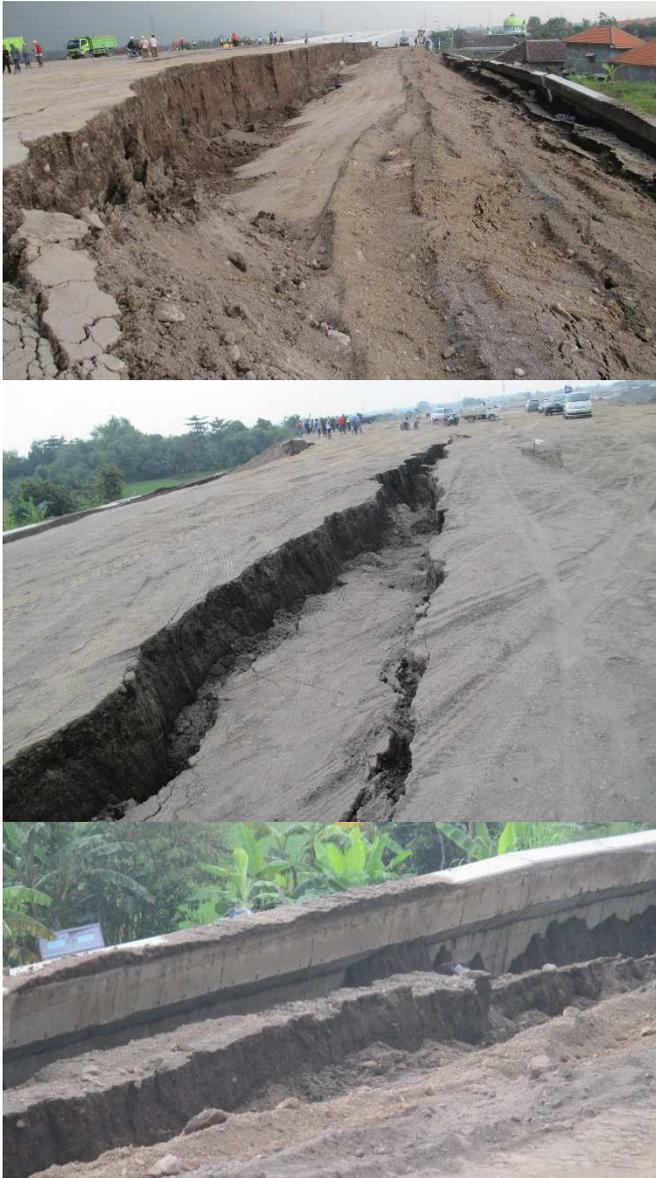
decline in the embankment elevation and the displacement of the retaining wall to a maximum depth of 3.50 m, as shown in Figure 1. Meanwhile, the embankment in the south zone was impact-free even though the retaining walls generally experienced horizontal movements between 10 and 20 cm.

Fig. 1 Landslides reduced the embankment elevation to 3.5 meters and damaged the existing retaining wall due to landslides.

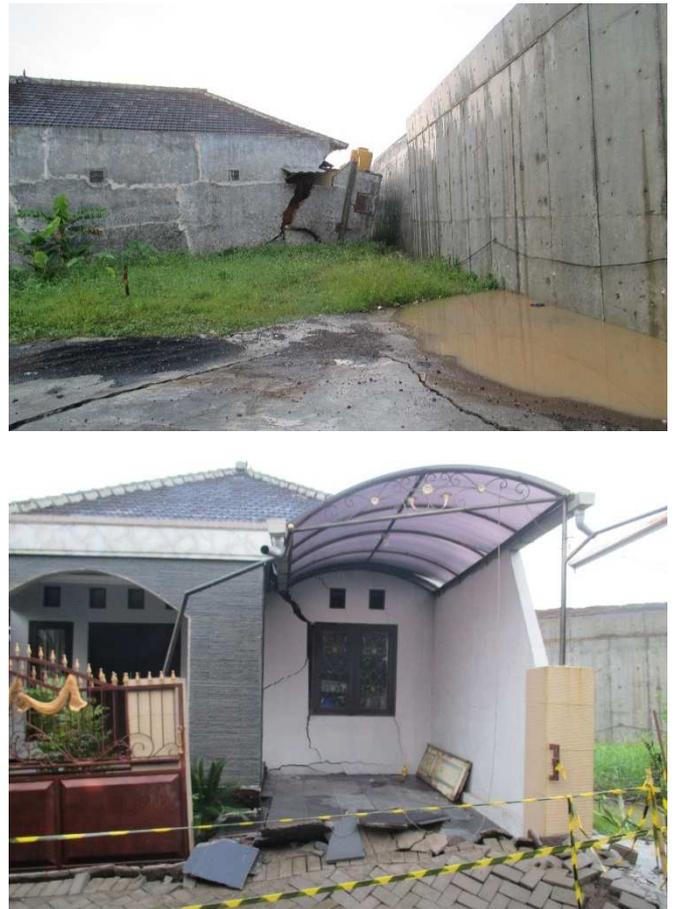
Fig. 2 The damage caused to the house close to the embankment landslide

The embankment construction was compacted layer by layer thickness of 20-30 cm. The landfill was made between July 2013 and March 2014, but cracks were reported in several residences around the south segment on January 30, 2014. Moreover, another crack was recorded in the housing area around the north section, the route to Gempol, on March 4, 2014. The houses with heavy faults were found to be 15 m from the embankment toe, with most of them seriously damaged, as indicated in Figure 2. These defects continued to increase with landslides and cracks discovered behind the north side of the retaining wall. Therefore, there is a need for long-term reinforcement to prevent further damage or subsequent landslides.
