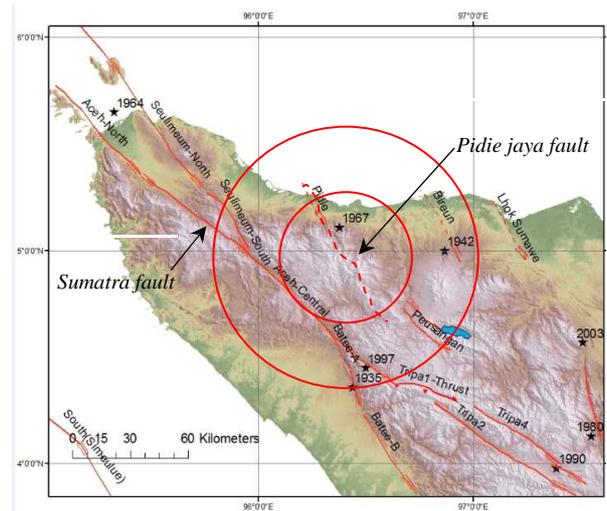
Fig.4 Pidie Jaya fault, another local fault, and great Sumatra Fault

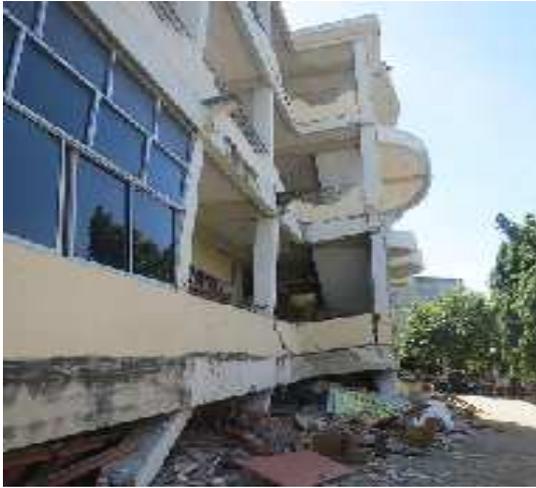
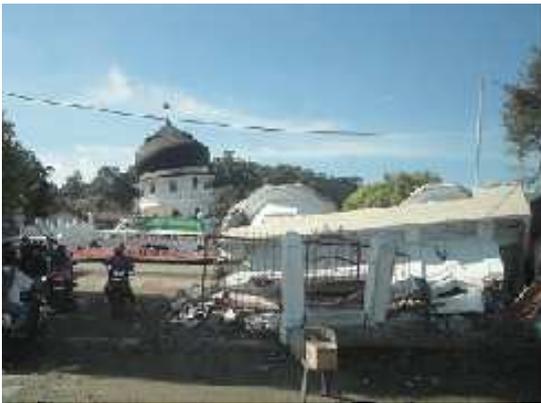
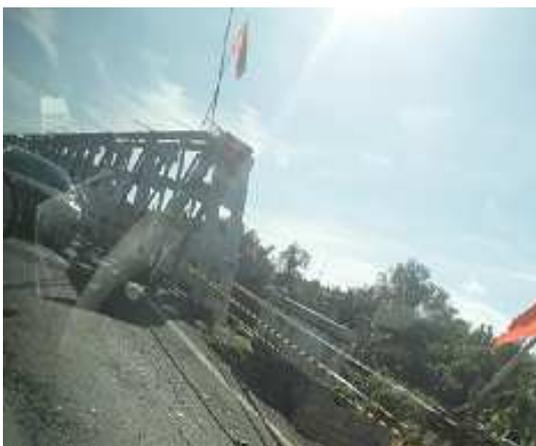
Fig. 5 (a) Total building collapse, (b) Mosque collapse and (c) Bridge abutment failure.

Fig. 5 shown three extreme collapsed; (a) buildings, (b) Mosques and (c) High peak base acceleration bridge abutment with possibly of low seismic amplification. Aceh province west shore is categorized in zone 5 to 6 scale (including the high score) for peak base acceleration (PBA) from 0.3g to 0.4g and nearby 0.25g to 0.3g for Banda Aceh region [2].

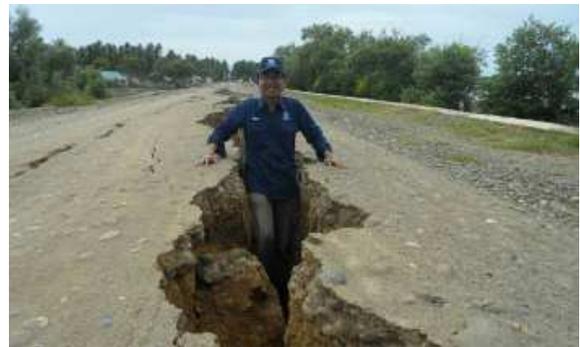
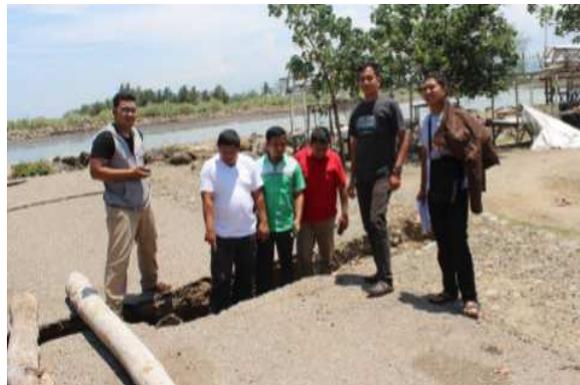
Fig. 6 (a) Ground failure of the road (b) located on Manohara fishpond with soft soil ground condition

A lot of possible factors related to variation in damages level. One of the factors would be site condition effect of bedrock to ground surface seismic amplification. Fig. 6 displays ground failure of road located along fishpond with the soft ground condition. Research about soil condition and some stabilization method in Aceh [3] and [4] are necessary to conduct to understand deeper the site condition of Aceh soil histories.

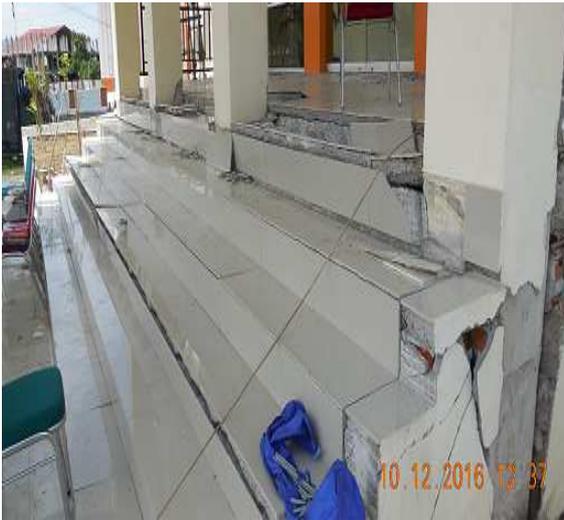
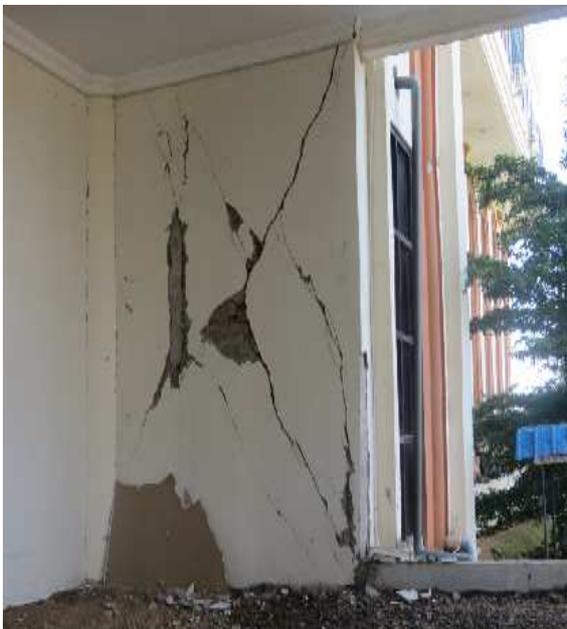
Fig. 7 Settlement caused by building rocking during earthquake ground shaking. (a) Office of the counsel for the prosecution and (b) Government office of Pidie Jaya district.

From Fig. Seven it is shown that the settlement of a structure is because of building overturning through ground shaking during the earthquake. The government office of the council for prosecution and Government office of Pidie Jaya district building failures seems because of lack of structural integrity rather than foundation failure and overburden pressure phenomena.

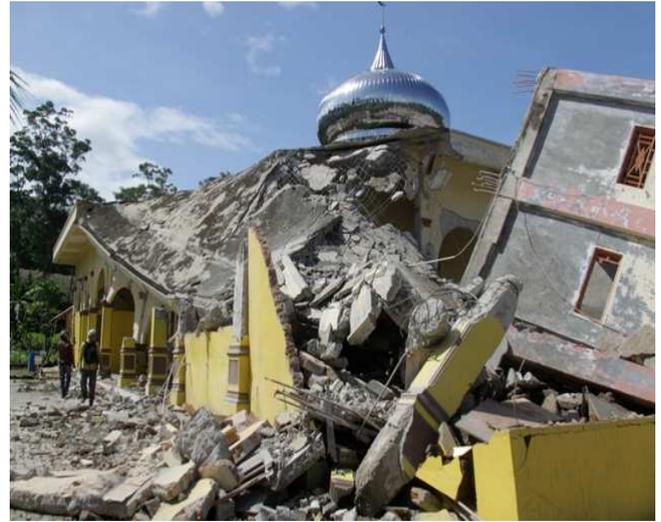
Fig. 8 Failures of vulnerable mosque due to high amplification of seismic ground motion inducing foundation failure.

Based on investigations, specific existences of potential liquefaction also ground failure in the area along the shoreline were detected as shown in Fig. 8 and Fig.9. Considering that common conditions of geotechnical data are medium dense with silty sand layers dominate in the soil profile, it seems that liquefaction occurred within the area just after firm earthquake shake with low to medium dense loose silty sand.

As only limited geotechnical data available, the presence of sandy like soil in a pond area inshore track is estimated. Fig. 8 displays completely collapse of mosques due to ground cyclic movement and resonance between natural soil

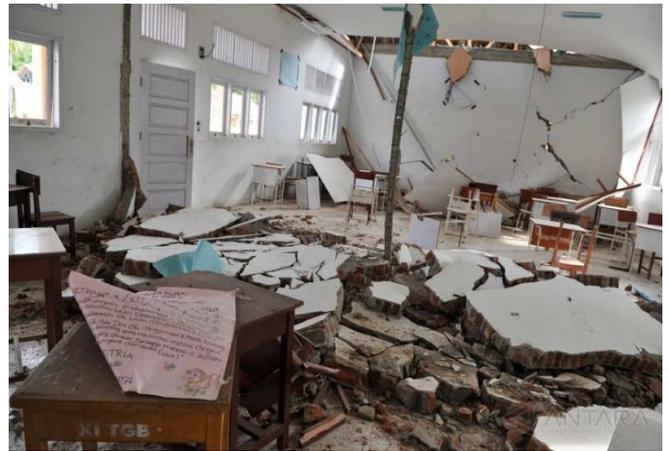
Fig. 9 Failures of school due to high amplification of seismic ground motion inducing foundation failure.

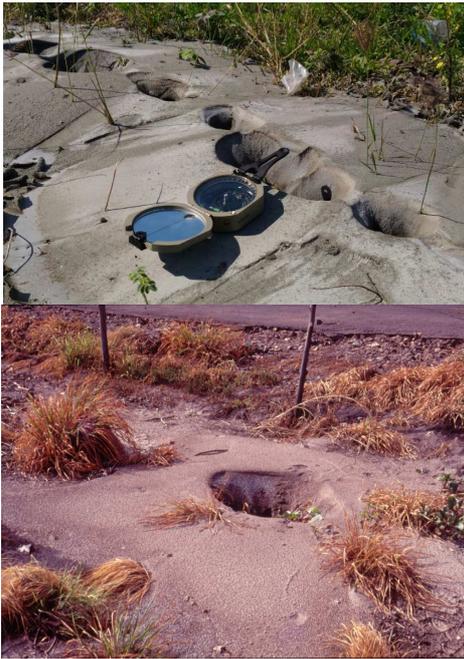
Fig. 10 Liquefaction phenomena at Manohara shorelines Pidie Jaya Aceh earthquake 7th December 2016.

Failures of embankments and bridges seem to be caused by due to poor design. Some several issues associated with variation in damages level. One of it is the effect of soil profile at the seismic local ground condition which increases from bedrock to ground surface beneath structures. The difference in the level of damages is measured vary by buildings vulnerability and the foundations, difference in peak surface acceleration of probable different site condition which might have liquefaction and ground failure, as shown in Fig. 10 and Fig. 11 respectively.

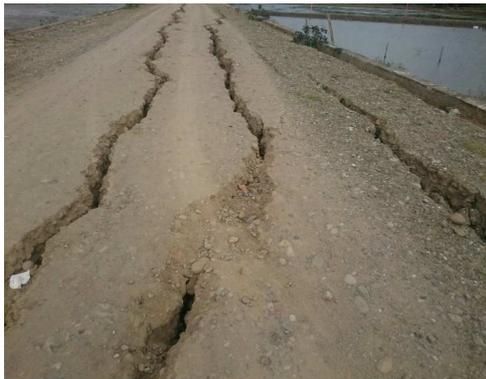
Fig. 11. Ground failure in Manohara-shorelines Pidie Jaya Aceh earthquake 7th December 2016.

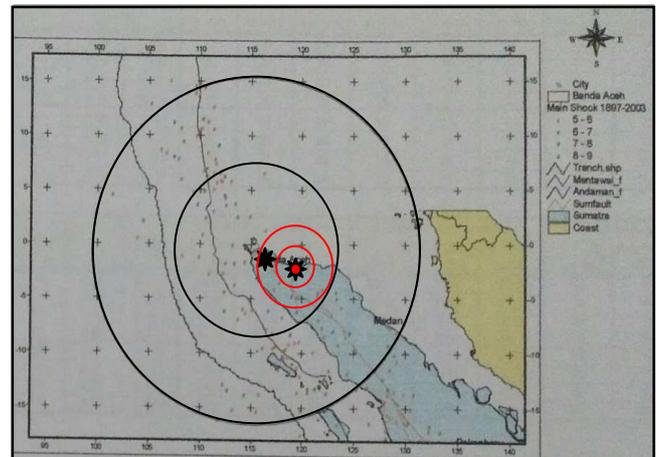
Fig. 12 Seismicity and source zone (epicenter) within a radius of 300km from Andaman earthquake (M=9.1, 2004) and radius 4km from Pidie Jaya earthquake (M=6.4, 2016).

Seismic source zones used in preliminary PSHA is shown in Fig. 12 and Fig. 13. The map of seismic microzonation would be valuable as a control for the supervision or private sector that dynamic load which has been signified. Furthermore, the map would be important for improvement of city maps risk within the city, which also needed spatial planning. Moreover, the combination of microzonation map with vulnerability in seismic risk assessment is used to formulate risk mitigation strategies for city development.

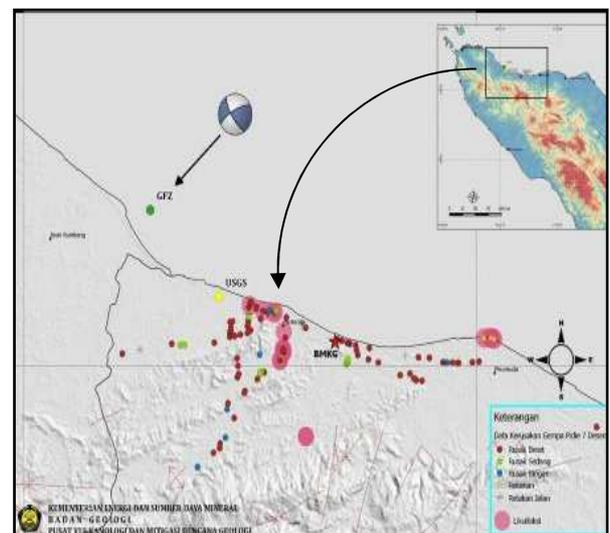
Fig.13. Seismicity summary of Pidie Jaya-Aceh aftershock earthquake 7th December 2016 (M=6.4).
