Study on the Behavior of a Simple House Partially Retrofitted Using Ferrocement Layers due to Earthquake Loads

Abstract— Earthquakes are a serious threat in Indonesia. Large-scale earthquakes that have occurred, such as the Aceh earthquake (2004), the West Sumatra earthquake (2009), the Lombok earthquake (2018), the Mamuju earthquake (2021), and most recently, the West Pasaman earthquake (2022), which caused many fatalities and damaged infrastructure and building houses, especially houses of the economically weak community. These houses were generally built using adobe bricks using the ½ brick masonry method without structural elements such as columns and beams that do not meet earthquake-safe house standards. In an effort to mitigate earthquake disasters, a strengthening method was developed in this study, namely by using ferrocement layers. In this research, a simple house model with adobe walls with a scale of 1:4 will be made, which will be partially strengthened using ferrocement layers tested on a vibrating table and given an earthquake load. Furthermore, numerical analysis was carried out to validate the results of experimental testing. The results of the tests show that th

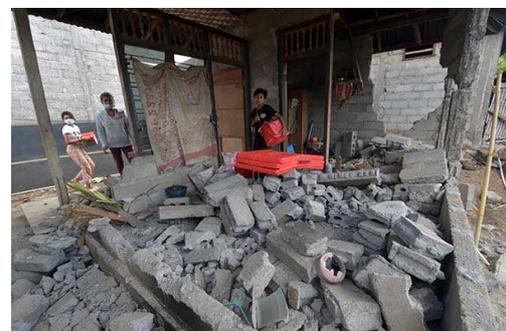
Fig. 1 Damage Simple Residential Houses Due to Earthquake

Earthquakes are a natural phenomenon that often occurs in Indonesia. The USGS recorded that, from 2004 to 2009, approximately 14 large-scale earthquakes hit Indonesia [1]-[5]. Another earthquake occurred in Indonesia in 2018, namely the Lombok earthquake. In 2021 there was the Mamuju earthquake, and most recently, in 2022, the West Pasaman earthquake. These earthquakes resulted in a large number of casualties and damage to infrastructure and buildings, especially simple residential buildings/houses for the economically weak community [6]-[11] (see Fig. 1).

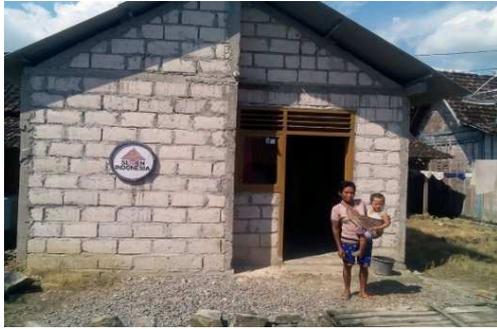
Fig. 2 Simple House

Most houses were built using brick or hollow bricks and built by the community or local craftsmen based on practical experience. They did not meet earthquake-resistant building standards [12]-[16] (see Fig. 2). Such house is certainly very dangerous for the community because the hollow bricks have heavy characteristics as they are made of a mixture of mortar and have brittle properties and almost no ductility, which can cause sudden collapse when an earthquake occurs [17]-[22]. To mitigate disaster and anticipate an upcoming earthquake, it is suggested to strengthen the houses as a whole [23], [24].

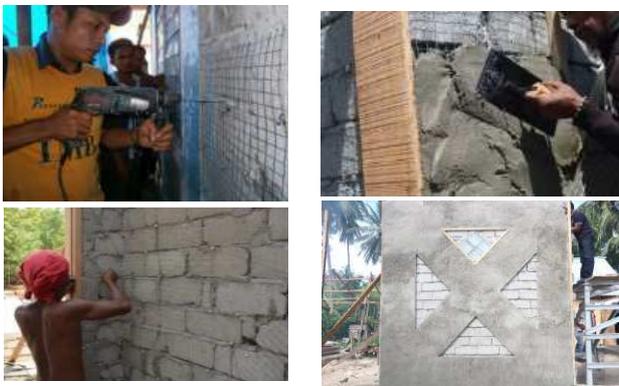
Fig. 3 Construction for Layer Ferrocement Reinforcement

The simple house modeled in this study is a type 36 hollow brick house with a size of 600 cm x 600 cm x 400 cm. The limitations of the testing equipment, both in terms of the area of the shaking table and the capacity of the motor drive, means the specimen is modeled on a 1:4 scale from its original size to 150 cm x 150 cm x 100 cm, as shown in Fig. 3a while Fig. 3b, 3c, 3d, 3e, 3f shows the appearance of the reinforced specimen housing.

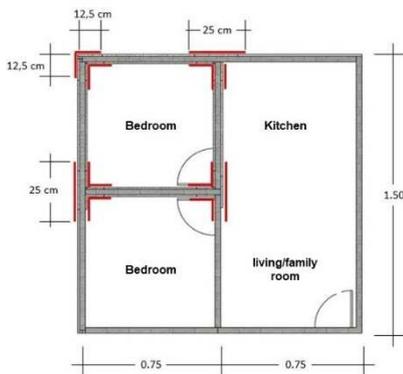
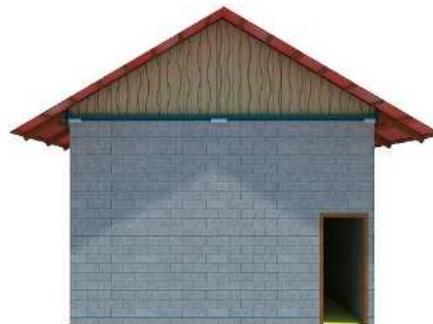
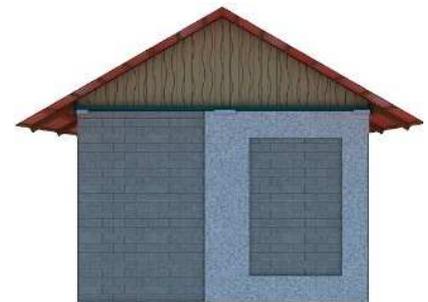
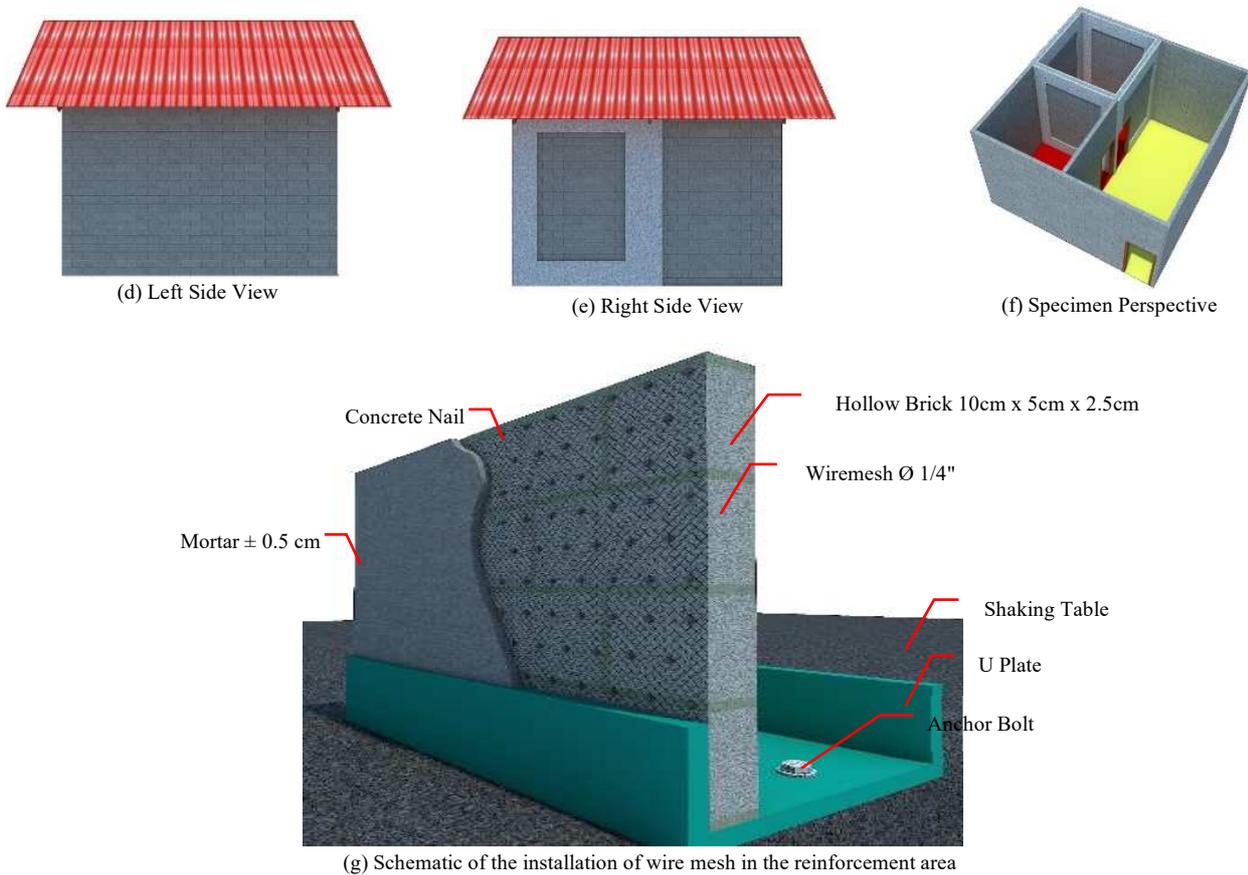
(a) Plan of the Specimen House Retrofitting Using Ferrocement Layers

(b) Front View

(c) Rear View

Fig. 4 Specimen and Schematic of the installation of woven wire in the reinforcement area

Reinforcement in the house is given partially using ferrocement layers; in this case, the reinforcement is given to one bedroom by coating the corners of the bedroom or on the sides, which are considered structural elements with ferrocement layers. Schematics and details of the installation of woven wire in the reinforcement area (Fig. 4 a, b, c, d, f and g).

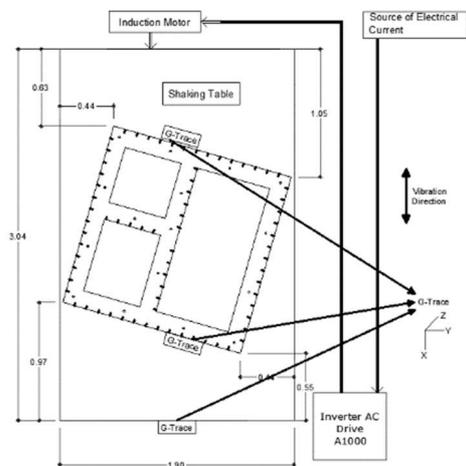
Fig. 5 Position of the U plate on the Shaking table

The position of the specimen on the shaking table refers to the Earthquake Loading Codes for Buildings and Other Structures (SNI 1729-2019), point 7.5.3 "the load is applied separately in all orthogonal directions. The effect of the most critical load due to the direction of application of earthquake forces on the structure is considered fulfilled if the components and foundations are designed to carry the following combination of applied loads: 100 percent (100%) force for one direction plus 30 percent (30%) force for perpendicular [29]. Then the inclination of the specimen on the shaking table is set at 16° along the x-axis (Fig. 5).

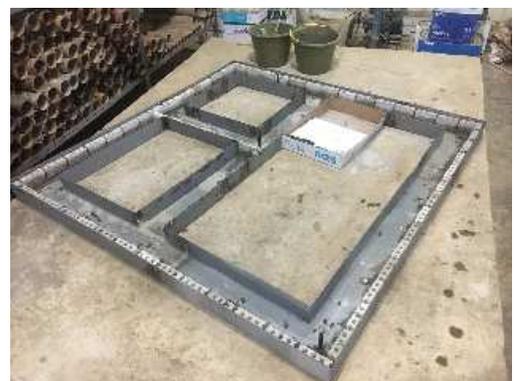
Fig. 6 Hollow Brick Wall Construction Process

The hollow bricks are arranged on a U plate with a height of 1 m with a specific thickness of 0.5 cm. The model is made from a 1:4 mixture of cement and sand (Fig. 6 and Fig 7).

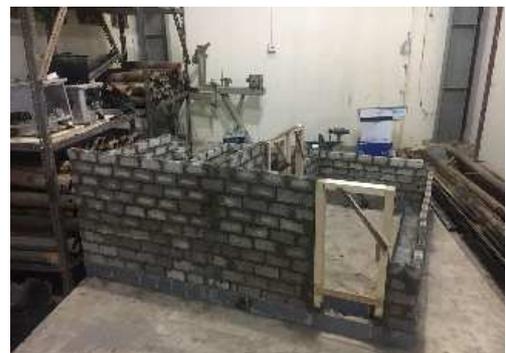
Fig. 7 Hollow Brick Wall Construction Process High 50 cm

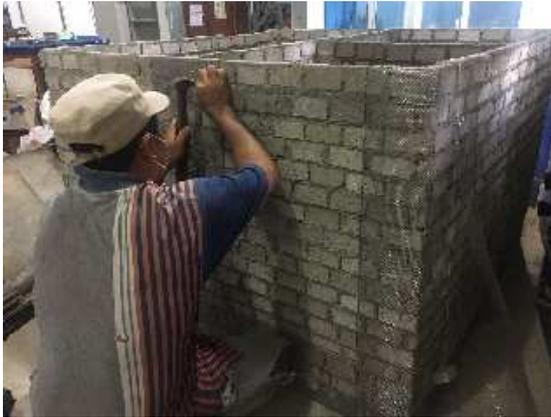
Nails are installed around the wall that will be given reinforcement. Nails are installed alternately with a distance of ± 5 cm. The woven wire is installed by tying it to a nail with a bendrat wire (Fig. 8).

Fig. 8 Wire Mesh Installation Process

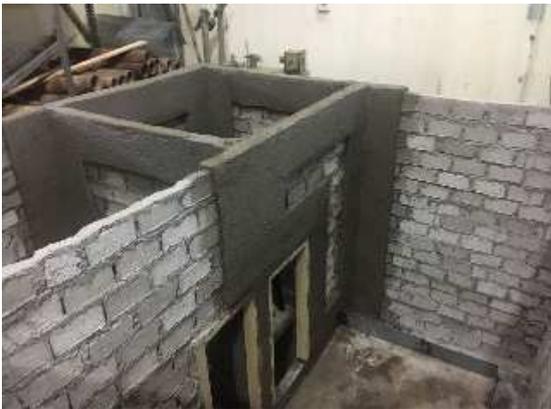
The part of the wall that has been lined with wire mesh is plastered with a mixture of cement and sand 1:4 with a thickness of 0.5 cm (Fig. 9).

Fig. 9 Plastering Process in Retrofitted Area

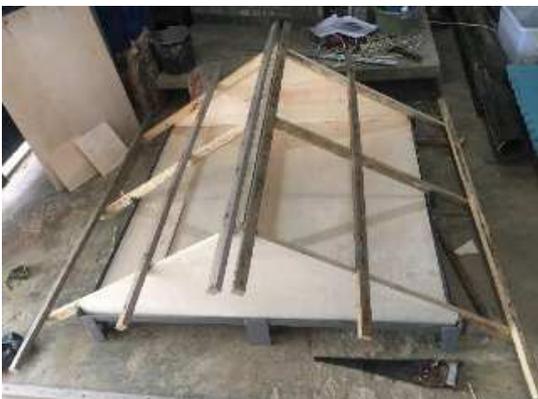
The roof frame is made of 4/6 wood as the trusses, while the roof covering is made of zinc roof with a thickness of 0.25 mm (Fig. 10). After the specimen-making process is complete (fig. 11), the specimen is ready to be tested on the shaking table.

Fig. 10 Roof Truss Making Process

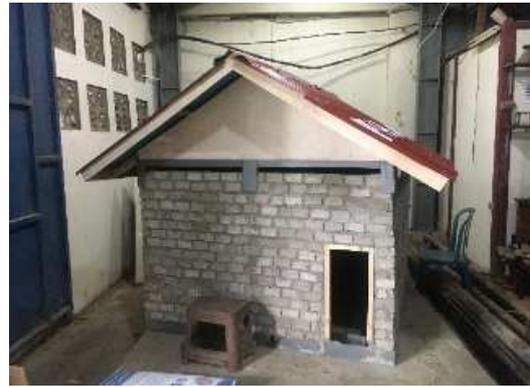
Fig. 11 Specimen After Construction

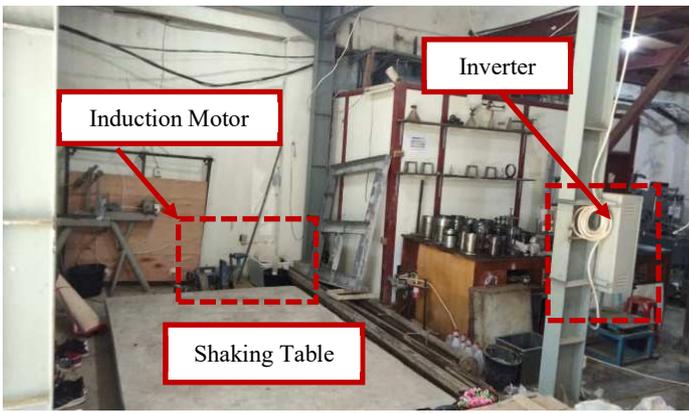
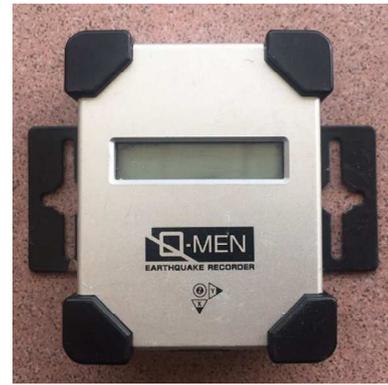
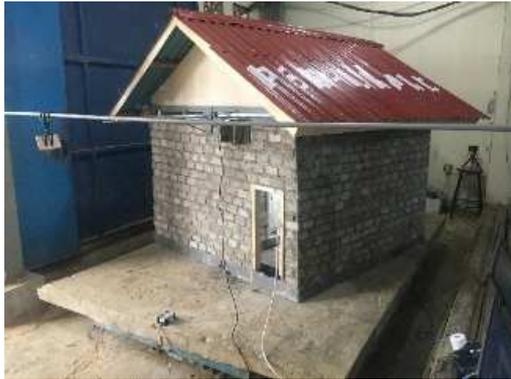
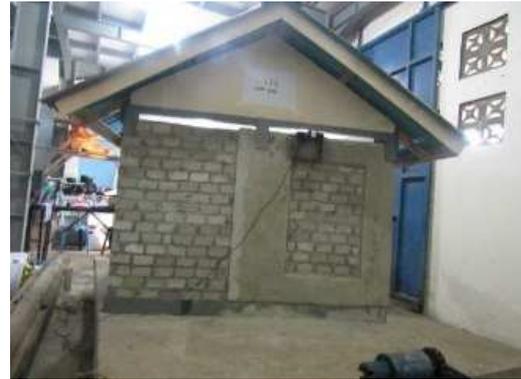
(a) Shaking Table

(b) G-men Gravity Shock Recorder (G-Trace)

(c) (G-Trace Tool Position in Front Specimen

(d) (G-Trace Tool Position in Rear Specimen

Fig. 12 Set Up Shaking Table Tool and G-Trace Position

Before testing, the shaking table tool is connected to the inverter (Fig. 12 a, b, c, and d). The inverter functions to regulate the frequency of vibrations that will be given to the shaking table so that it can produce vibrations according to the earthquake acceleration planned in this study.

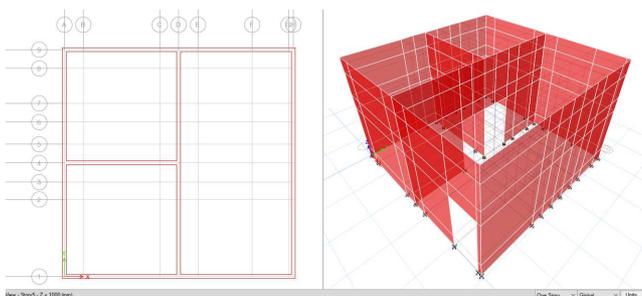
Fig. 13 Specimen modeling in numerical analysis

Numerical analysis was performed using finite element software to validate experimental test results. Numerical analysis was carried out by making the same model as the experimental test (Fig. 13).

In the numerical analysis modeling of the specimen, there are three specified materials. The first is hollow brick with a specific gravity of 1600 kg/m^3 , compressive strength (f_c') 2.5 MPa, modulus of elasticity 7431.36 Mpa, and shear modulus of 3096.4 Mpa. Both plasters have a specific gravity of 1600 kg/m^3 , a compressive strength of 9.9 MPa, an elastic modulus of 14788.2 Mpa, and a shear modulus of 6161.75 Mpa. Third is Stainless Steel with ultimate tensile strength (f_u) 620 Mpa, yield tensile strength (f_y) 275 Mpa, specific gravity 8.0 g/cm^3 , and shear modulus 187500 Mpa [30], [31].

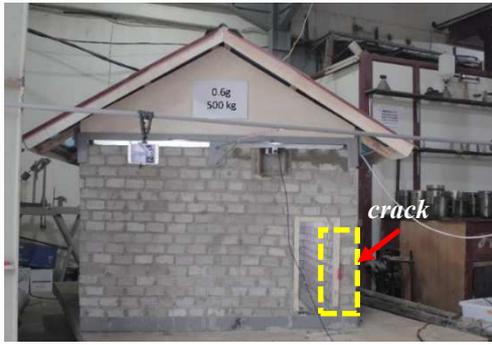
Fig. 14 The Condition of the Front of the Specimen at the time of an earthquake acceleration of 0.6 g

At an earthquake acceleration of 0.6 g with an additional dead load of 500 kg and a displacement maximum 1.2 cm, the specimen has small cracks in an area that is not reinforced, namely at the opening of the living room door (Fig. 14). In other parts of the wall, such as the back wall, left side, and right side as well as the reinforced wall, there is no crack or damage at all.

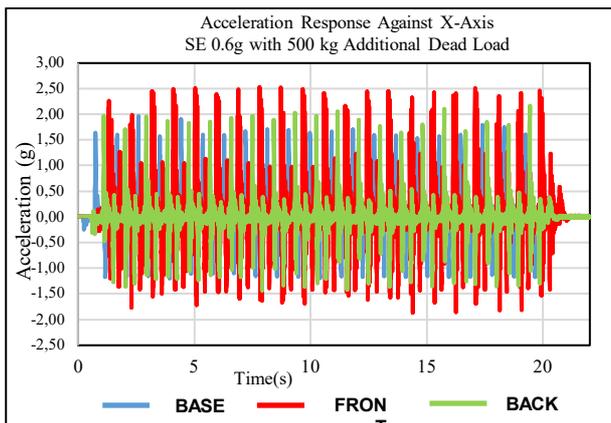
Fig. 15 Graph of 0.6 g . earthquake acceleration response

The acceleration response was obtained from the recording of the G-Trace device attached to the specimen. At the time of the earthquake acceleration of 0.6 g, the response of the earthquake acceleration (Fig.15). The blue line represents the acceleration response on the table (BASE), the red line represents the response on the unreinforced specimen wall (FRONT) and the green line represents the acceleration response on the reinforced wall (BACK). When the earthquake acceleration is 0.6 g, the maximum acceleration that occurs at BASE is 1.9 g, the maximum acceleration in FRONT is 2.5 g, and the maximum acceleration in BACK is 2.1 g.

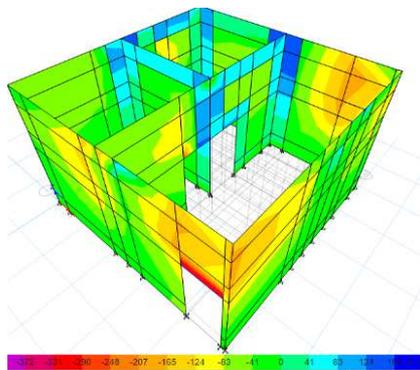
Fig. 16 Stress Patterns On The Wall Due to an Earthquake Acceleration of 0.6 g

Based on the results obtained experimentally, to find out the numerical behavior that occurs in the specimens, numerical analysis is carried out using the 2016 ETABS computer tool (Fig. 16).

From the results of the analysis on ETABS 2016, it can be seen that the distribution of tensile stresses is around the opening. For walls that are not reinforced, the maximum tensile stress value that occurs at the first crack point is 0.25 Mpa, where the tensile stress value is greater than the tensile stress of the hollow brick, which is 0.20 Mpa in equation (2).

This results in cracks in the unreinforced walls. Meanwhile, on the bedroom wall, which is reinforced with ferrocement layers, the tensile stress value that occurs is smaller than the tensile stress on the unreinforced wall, which is 0.18 Mpa on brickwall and 0.08 Mpa on plastering, where the stress is smaller than the tensile stress of the hollow brick and the tensile stress of the plaster so that it does not cause cracks in the walls.

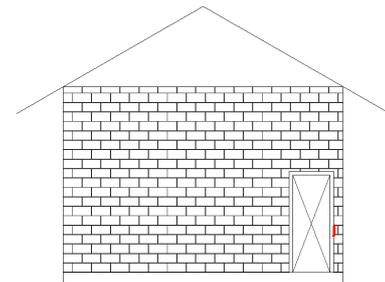
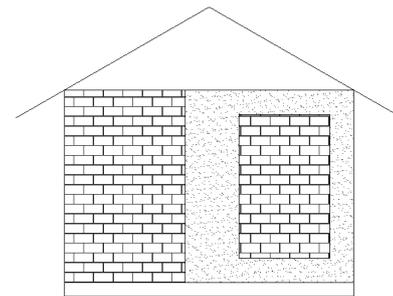
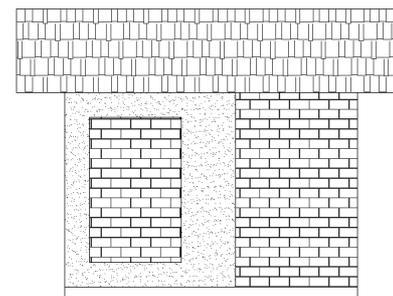
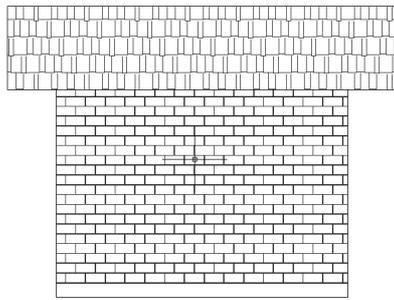
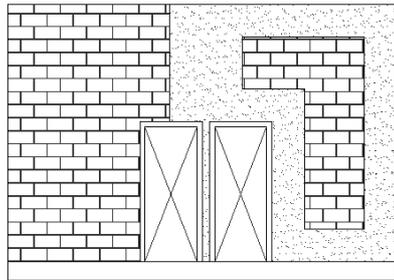
a. Front View

b. Rear View

c. Right Side View

d. Left Side View

e. Bedroom

Fig. 17 Crack Pattern Schematic During Earthquake Acceleration 0.6 g

The crack pattern occurs during an earthquake acceleration of 0.6 g for 20 seconds (Fig. 17 a, b, c, d, and e). There is a small crack on the front wall, namely in the door opening in the area that is not given reinforcement, which is depicted in red.

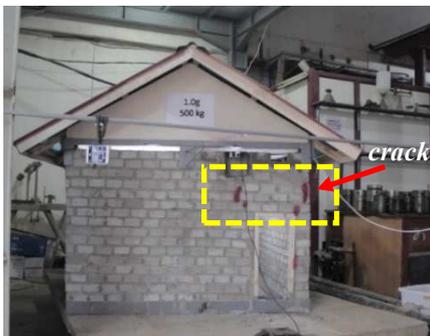
Fig. 18 Condition of the Front of the Specimen at the time of an earthquake acceleration of 1.0 g

1.0 g earthquake acceleration with an additional dead load of 500 kg with a displacement occurred during the maximum acceleration of 3.11 cm. The cracks in the specimen increased occurred in the upper wall of the living room door opening (wall without reinforcement) (see Fig. 18). Cracks also occurred on the left side wall of the living room, namely in the meeting area between the walls (Fig. 19). In the bedroom area which was partially reinforced with the ferrocement method, no cracks or damage occurred at all.

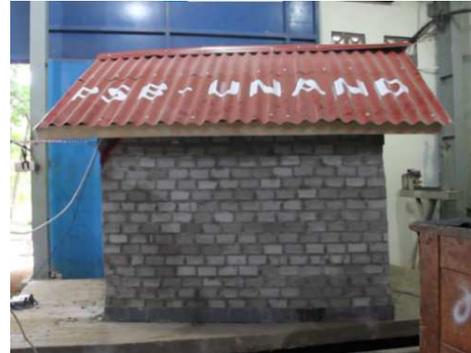
Fig. 19 Condition of the Left Side of the Specimen at the time of an earthquake acceleration of 1.0 g

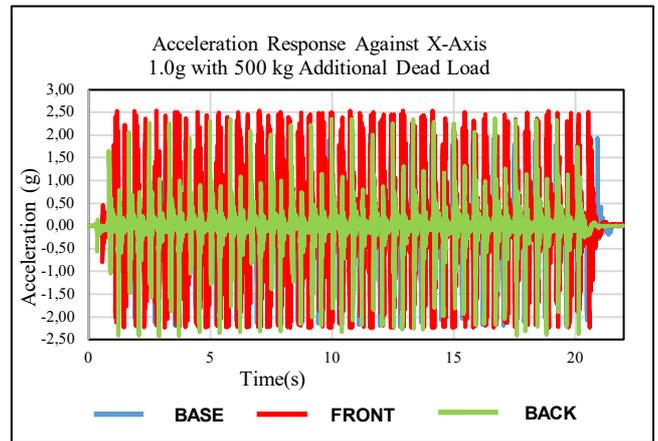
Fig. 20 Graph of 1.0g earthquake acceleration response

During an earthquake acceleration of 1.0 g, the acceleration response from the recording of the G-Trace tool occurred (Fig. 20). New cracks occurred in the 10 seconds of the experiment with the maximum acceleration value at t = 10 seconds of 1.9 g, which occurred in the BASE, 2.5 g which occurred in the FRONT, and 2.3 g which occurred in the BACK.

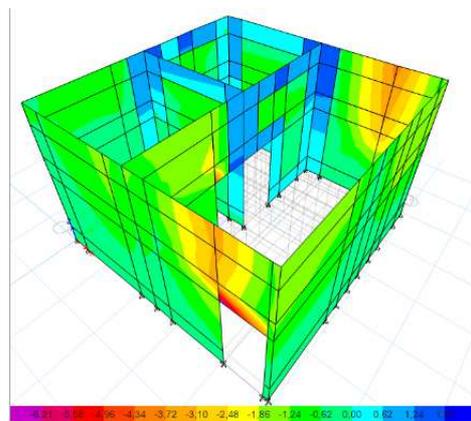
Fig. 21 Pattern of Stress on the Wall due to an Acceleration of an Earthquake 1.0 g

From the analysis of the distribution of the maximum compressive stress in the vicinity of the opening, (Fig. 21) shows that in unreinforced walls in the area where cracks occur, the maximum tensile stress value is 0.55 MPa, where the stress is greater than the tensile stress of the hollow bricks.

Meanwhile, the maximum compressive stress is 6.62 MPa, greater than the bricks' compressive stress. So, this is what causes cracks in the walls without reinforcement. The maximum tensile stress value in the bedroom is 1.65 MPa for hollow brick and 0.13 MPa for plaster. Although the tensile stress on the hollow bricks is greater than the tensile stress of the bricks, the reinforcement of ferrocement layers can significantly increase the capacity of the hollow brick wall elements so that it does not cause cracks in the walls.

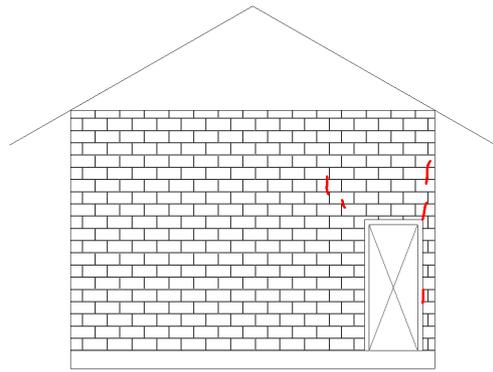
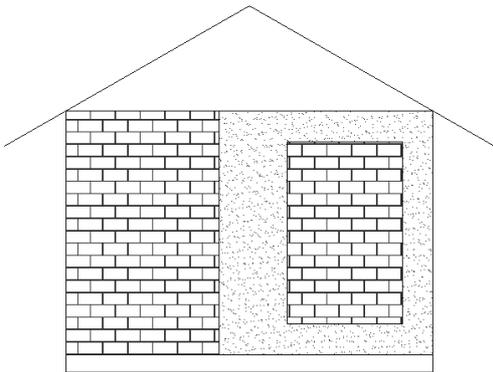
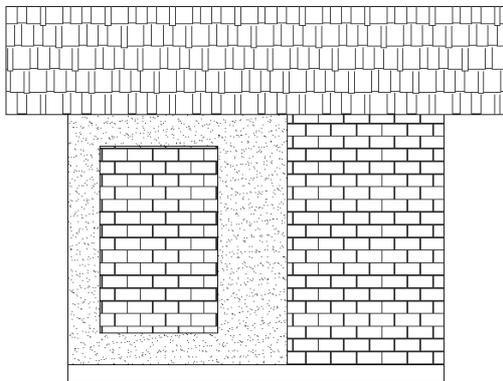
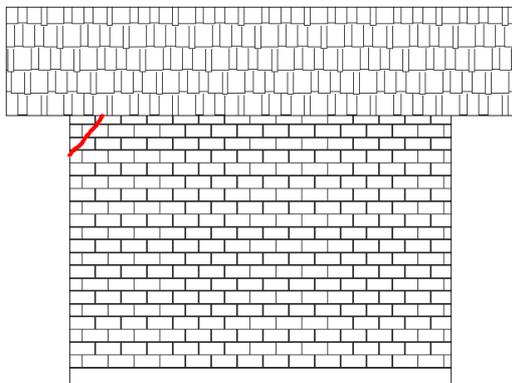
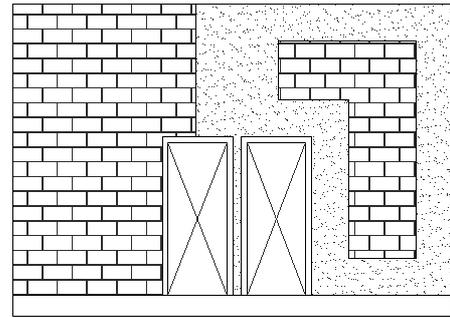
a. Front View

b. Rear View

c. Right Side View

d. Left Side View

e. Bedroom

Fig. 22 Crack Pattern Schematic During Earthquake Acceleration 1.0 g

The crack pattern that occurs at the 1.0 g earthquake acceleration input for 20 seconds (Fig. 22). New cracks occur

on the front wall, namely in the door opening in the area that is not given reinforcement, which is depicted in red.

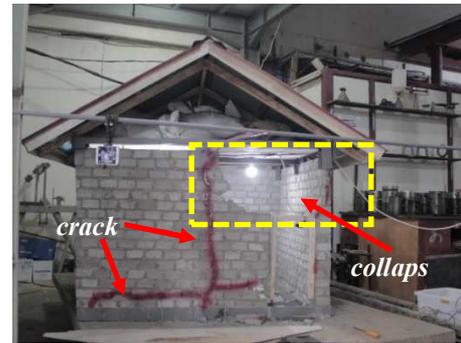
Fig. 23 Condition of the Front of the Specimen during an earthquake acceleration of 1.5 g

By increasing the earthquake acceleration to 1.5 g, after 20 seconds of experimentation, the specimen was severely damaged with displacement at maximum acceleration of 4.88 cm. The living room wall (unreinforced wall) in the front, precisely the wall above the door opening area, collapsed. Cracks also occurred vertically at the meeting of the living room wall with the bedroom wall without reinforcement (Fig. 23).

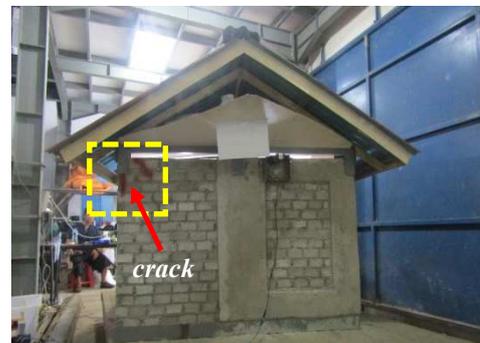
Fig. 24 Condition of the Back of the Specimen during an earthquake of 1.5 g

Meanwhile, on the back wall of the living room there were cracks in the area where the walls meet (Fig. 24). Cracks also occurred on the left side wall of the living room (Fig. 25). The unreinforced bedroom wall also had cracks on the right and left sides. In the right-side wall, the crack occurred horizontally at the top (Fig. 26). On the left side wall, cracks occurred diagonally at the door opening area and horizontal cracks at the bottom.

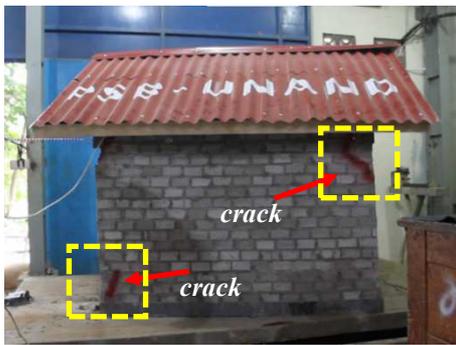
Fig. 25 Condition of the Left Side of the Specimen during an earthquake acceleration of 1.5 g

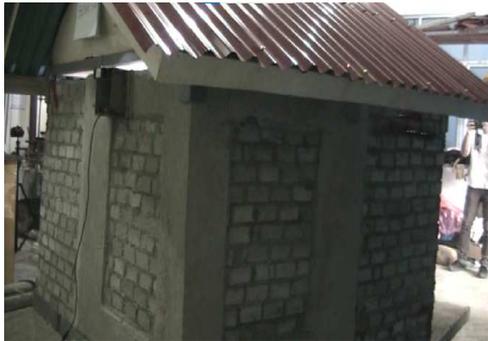
Fig. 26 Condition of the Right Side of the Specimen at the time of the 1.5 g earthquake acceleration

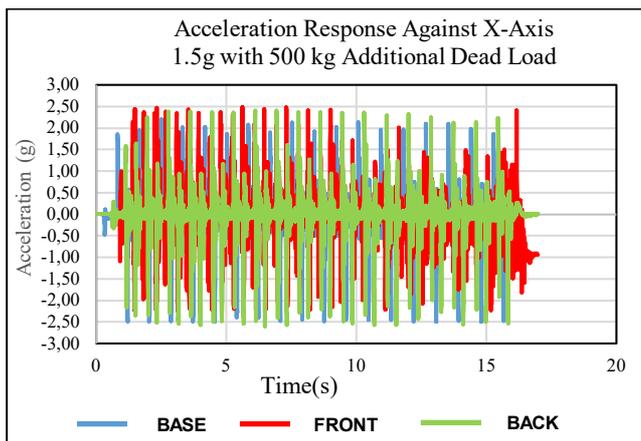
When the earthquake acceleration is 1.5 g with an additional dead load of 500 kg, the graph of the earthquake acceleration response $t = 20$ seconds (Fig. 27). Where a new crack occurred during the five seconds of the experiment with the maximum acceleration value at $t = 5$ seconds of 2.5g which occurred in the BASE, 2.4g which occurred in the FRONT and 2.5g which occurred in the BACK. Meanwhile, the specimen undergoes initial collapse at time $t = 15$ seconds. The maximum acceleration value at $t = 15$ seconds is 2.5 g, which occurs at BASE, 2.4g in FRONT and 2.6g in BACK.

Fig. 27 Graph of 1.5 g earthquake acceleration response

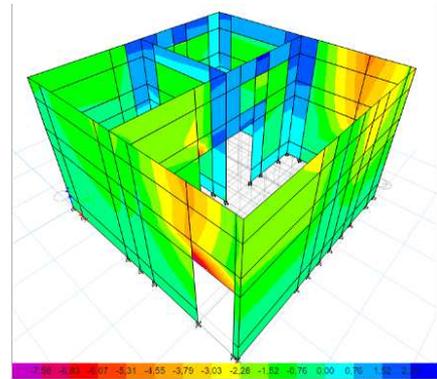
The analysis (Fig. 28) shows compressively tensile stress in the cracked area. In the area that experienced a collapse, the maximum tensile stress value on the hollow brick wall was 1.38 MPa, where the stress was greater than the tensile stress of the hollow brick. While the maximum compressive stress,

which is the most dominant stress, is also greater than the compressive stress of the hollow bricks, which is 7.58 Mpa. So, this is what causes the collapse and new cracks in the walls without reinforcement. In bedroom walls, the maximum tensile stress on brick walls is 2.33 MPa and on plaster is 0.93 MPa, although the tensile stress on the hollow brick walls is greater than the tensile stress of the hollow bricks with the reinforcement of ferrocement layers so that it does not cause cracks in the walls.

Fig. 28 Stress Pattern on Walls Due to Earthquake Acceleration 1.5 g

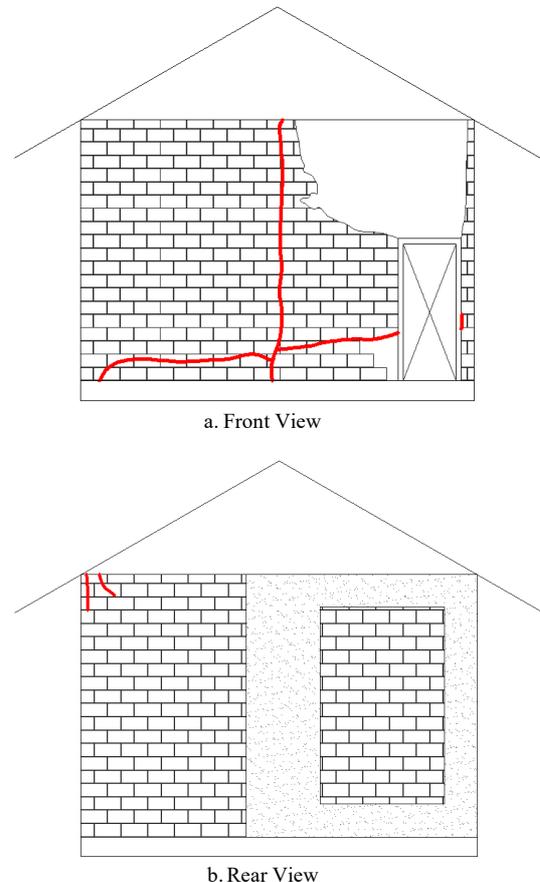
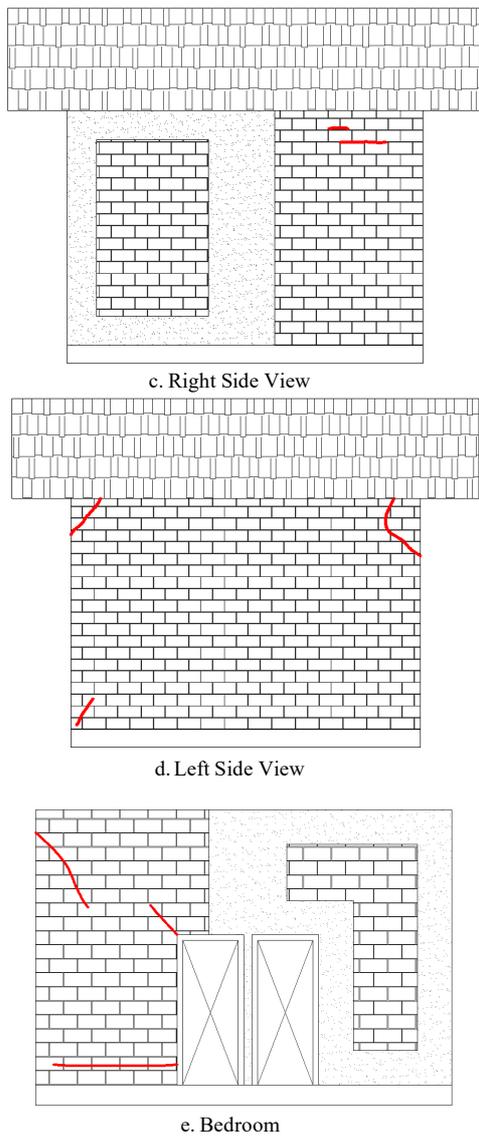
The crack pattern occurs in the specimen during an earthquake acceleration of 1.5 g (Fig. 29), where the specimen has new cracks and an initial collapse for 20 seconds of the experiment. The collapse occurred in the upper wall of the living room door opening.

Fig. 29 Crack Pattern Schematic During Earthquake Acceleration 1.5 g

At an earthquake acceleration of 1.5 g with a displacement of 4.88 cm, the specimen experienced an initial collapse in the area of the living room door opening (unreinforced walls). From numerical analysis, it is known that the cause of failure is the maximum tensile stress value that occurs is greater than the tensile stress of the hollow bricks and the maximum compressive stress that occurs is also greater than the compressive stress of the hollow bricks.

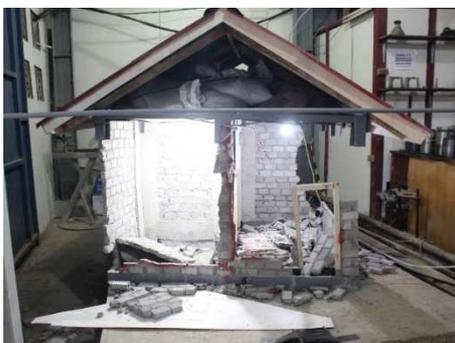
a. Condition of the Front of the Specimen during an earthquake acceleration of 1.5 g to Collapse.

The specimens were tested again with an earthquake acceleration of 1.5 g with an additional dead load of 500 kg until the specimens were severely damaged. Condition of the specimen at an acceleration of 1.5 g in the second experiment (Fig. 30 a, b, c, and d). Most of the unreinforced walls fail.

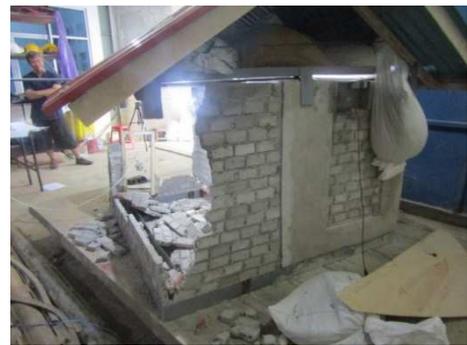
b. Condition of the Back of the Specimen

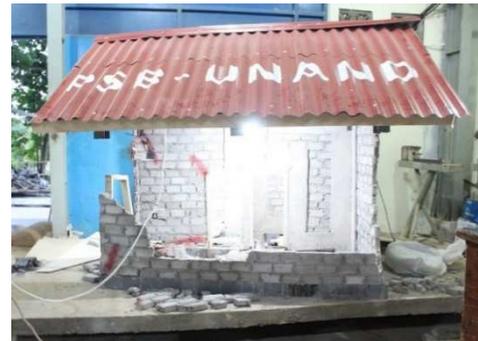
c. Condition of the Left Side of the Specimen

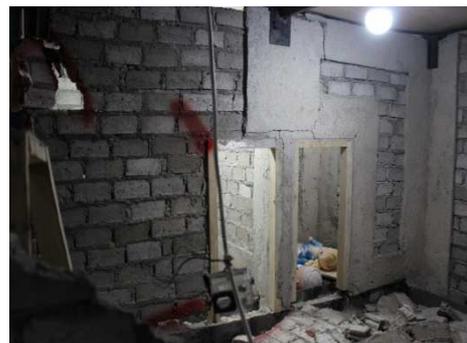
d. Condition of the Inside of the Specimen

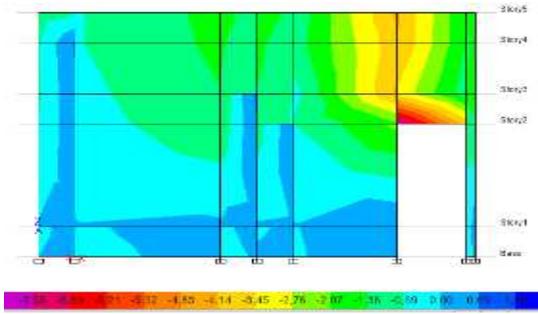
From the numerical analysis on the front wall of the living room (wall without reinforcement). Figure 31 shows that the maximum tensile stress is greater than the tensile stress of the hollow brick, which is 1.38 Mpa, and the compressive stress that occurs, which is the most dominant stress, is also greater than the compressive stress. Hollow brick is equal to 7.58. So, this is what causes the collapse of the wall. Figure 32 shows the stress distribution on the walls of a bedroom with reinforcement and a bedroom without reinforcement. In the bedroom without reinforcement, the maximum tensile stress on the hollow bricks is greater than the tensile stress of the hollow bricks, which is 0.60 Mpa, and the compressive stress is 5.33 Mpa, which is also greater than the compressive stress of the bricks. The stress in the wall exceeds the hollow brick's capacity, causing the unreinforced wall's collapse. While in the bedroom with a maximum tensile stress of 2.33 Mpa, the maximum stress is greater than the tensile stress of the hollow

Fig. 31 Stress Distribution on the Front Living Room Wall

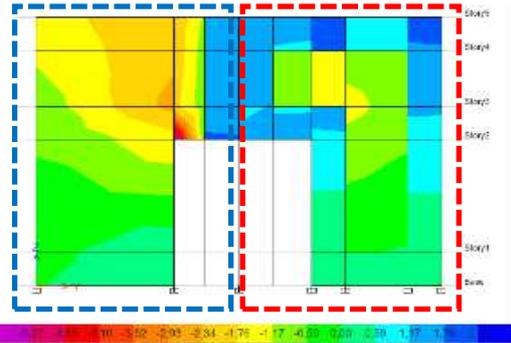
bricks, causing small cracks to occur in the area of the bedroom door opening but not causing a collapse.

Fig. 32 Stress Distribution on Reinforced and Unreinforced Bedrooms

This, of course, visually proves that the reinforcement using the ferrocement layers method can significantly increase the capacity of the hollow brick wall elements, making the bedroom walls that are given reinforcement able to withstand and be safe against earthquake loads, even up to an earthquake acceleration of 1.5 g, so that homeowners, in this case, simulated being in a reinforced bedroom when the earthquake occurred also survived the earthquake. There were no casualties (Fig. 33).

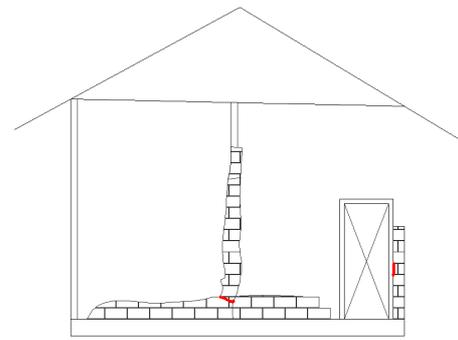
a. Front View

Fig.34 Crack Pattern Schematic During Earthquake Acceleration 1.5 g Until Collapse

The pattern of cracks that occur in the specimen during the acceleration of the 1.5 g earthquake, where the specimen is tested until it is severely damaged (Fig. 34). During the 35 seconds of the experiment, the specimen was severely damaged, namely, the specimen collapsed suddenly on the unreinforced wall, while the reinforced wall only experienced small cracks and did not collapse.

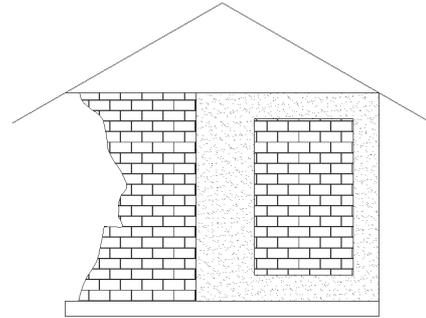
b. Rear View

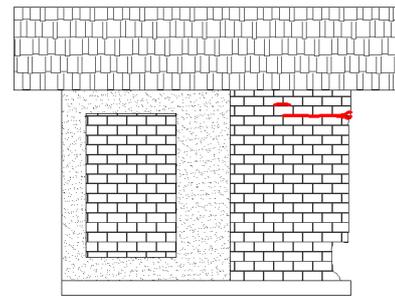
c. Right Side View

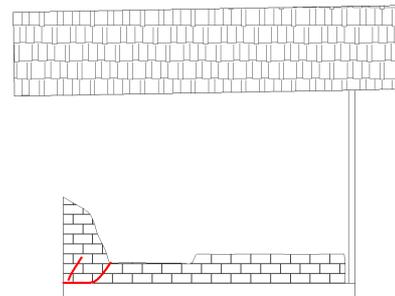
d. Left Side View

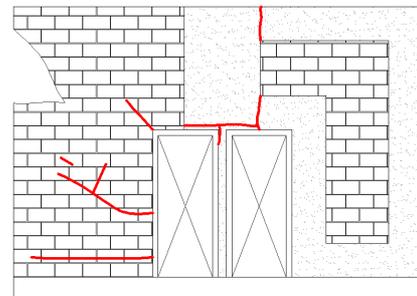
e. Bedroom
